# USB socket-outlets scrutinised

Our attention has now turned to new types of product that are becoming increasingly popular — 13 A socket-outlets, extension leads and adaptors that incorporate USB power supplies.

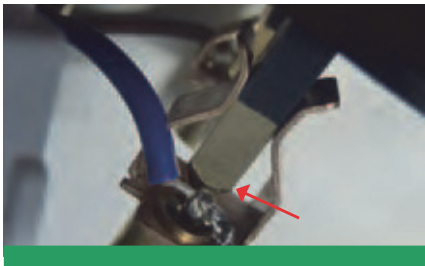
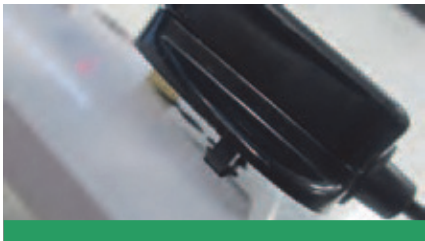
Fig 2. Soldered connections in the accessory prevented the test plug being fully inserted

In another sample, the internal conductors used to power the PCB were soldered onto the live (line and neutral) socket contacts into which the live pins of 13 A plugs should fit.

However, as Fig 2 shows, the soldered connections prevented the test plug from being fully inserted, creating a potential source of overheating. Furthermore, should such a solder-only power connection fail, displacement of the wire could result in an earth fault, short-circuit, or mains voltage appearing at the USB charger output, creating a risk of electric shock and/or fire.

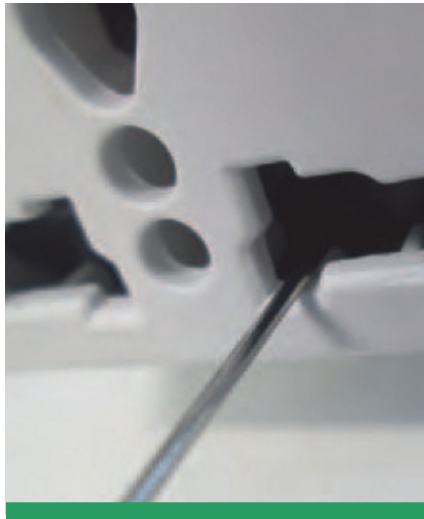
**Fig 3.** Access to live parts

To assess the accessibility of live parts, a standard 1.0 mm diameter test pin was applied with a force of 5 N perpendicular to the accessible external surface(s) of each of the samples.

One sample, No. 7, failed this test due to poorly fitting shutters over the apertures to the live contacts in the socket-outlet, as shown in Fig 3. In fact, as shown in Table 1, this particular sample performed worse of all, failing 8 of the 12 test criteria.

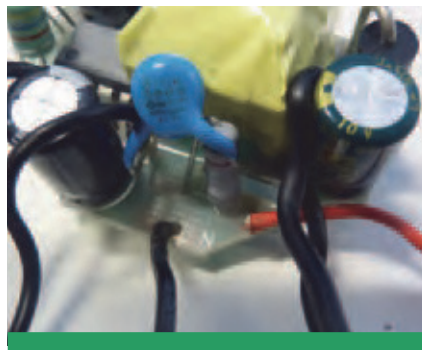
**Fig. 5** Point at which Sample No. 6 failed the electric strength test

All but one of the samples passed the standard dielectric strength. The one that failed did so at just 800 V d.c. A burn test later revealed that arcing had occurred between the fusible resistor and the tail of a capacitor which, as can be seen in Fig 5, had been in direct contact with one another.
