# Safety Screening Report

**Report:** 071-75924520-502

**Product:** Electrical Socket

| Testing Information | |
|---|---|
| Product Description: | Single Wall socket with a USB Port |

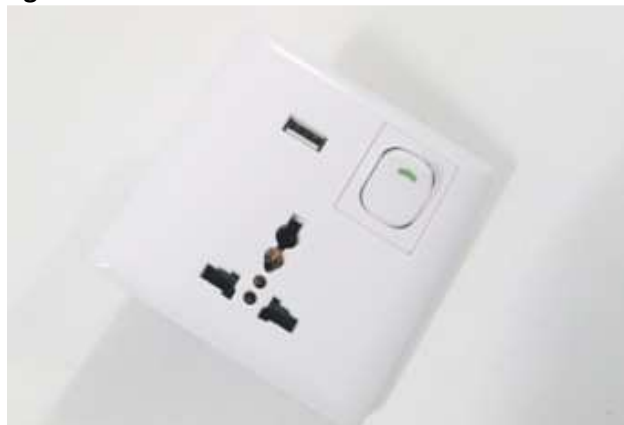
**Figure 1**

**Summary:** TÜV SÜD Product Service was commissioned by The Electrical Safety Council to evaluate an Electrical Socket (see figure 1). The aim of the assessment is to assess the product against the clients Safety Screening Test Plan.

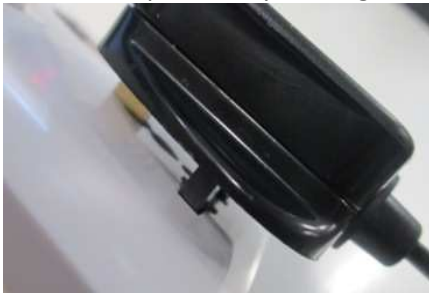
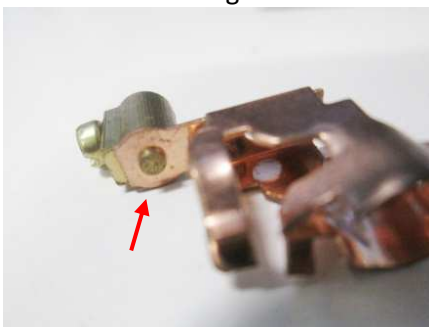
| Terminals & Terminations<br>(BS 1363, Clause 11) | |
|---|---|
| Comments | <p>A number of BS 1363 approved plugs failed to fully fit into the socket. It was found that the earthing pin required some manipulation to enable it to fully insert. This movement caused some deformation to live and neutral output conductors, potentially causing stress on to the attached input conductors.</p> <p>The copper part of the earthing conductor was pressed onto the brass part and not welded as expected. This assembly was also noted to be loose within the moulding.</p> |

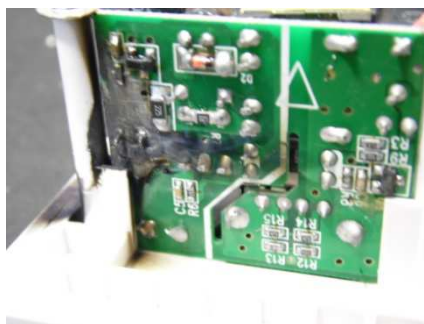
The device was setup with a load bank and the load slowly increased to 0.5A. The temperature was monitored around the device. After about 1.5 hours the sample exploded and the test was stopped. Both USB socket wires were blown off the PCB and it appeared an 8.2Ω surface mount resistor exploded.

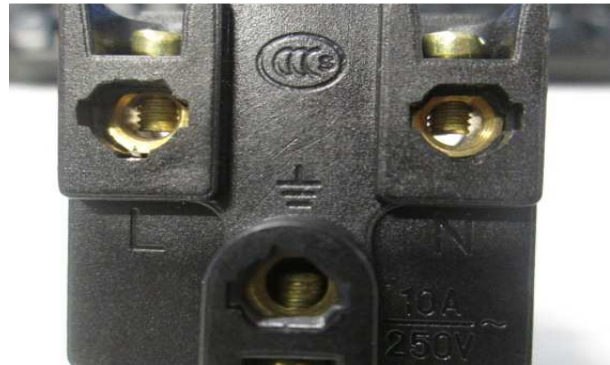
**Markings**

| Findings | | | |
|---|---|---|---|
| Comments | <p>The product as a unit was unmarked. A model reference, distributor name / trademark, WEEE log and CE marking were missing and must be present.</p> <p>The socket assembly was marked with electrical ratings and the CCC mark which could not be verified online. BS 1363 was not present; therefore not considered to be UK approved. The conductor inputs were clearly marked.</p> <p>The switch was also marked with the CCC mark. The switch current rating stated was 10A for a 13A socket. A part reference / manufacturer trademark was missing. The USB output ratings were missing and should be made available / visible to the end user.</p> <p>There were no instructions supplied with the product to enable an assessment. Information covering general safety, installation and operation should be made available to the installer / end user. The packaging stated that the product was suitable for digital products including mobile phones, cameras and MP3s.</p> | | |
