# Safety Screening Report

**Report:** 071-75924520-701

**Product:** Electrical Socket

| Testing Information | |
|---|---|
| Product Description: | Double Wall Socket with USB Ports |

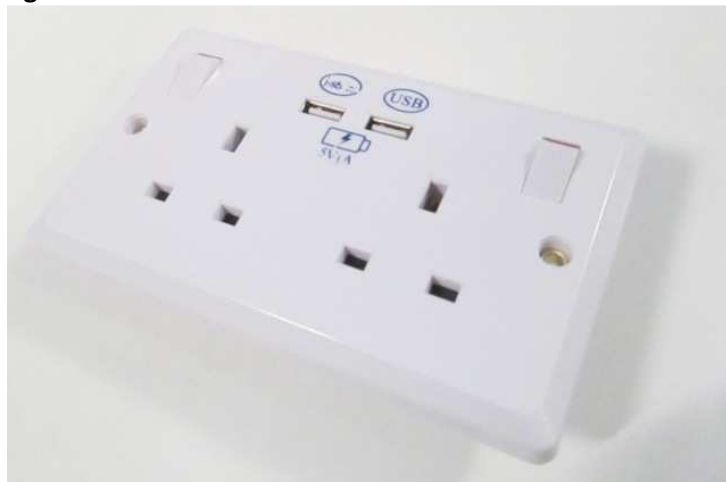
**Figure 1**

**Summary:** TÜV SÜD Product Service was commissioned by The Electrical Safety Council to evaluate an Electrical Socket (see figure 1). The aim of the assessment is to assess the product against the clients Safety Screening Test Plan.

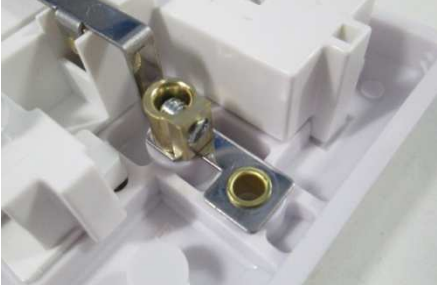
| Terminals & Terminations<br>(BS 1363, Clause 11) | |
|---|---|
| Comments | <p>A number of BS 1363 plugs could be inserted fully into the socket with no issues found. The input conductors were well constructed in brass.</p> |

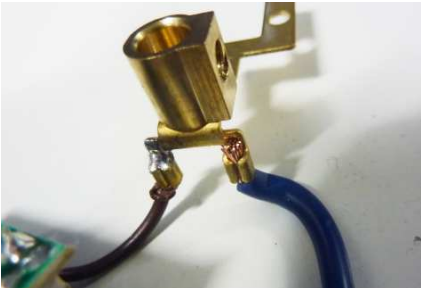
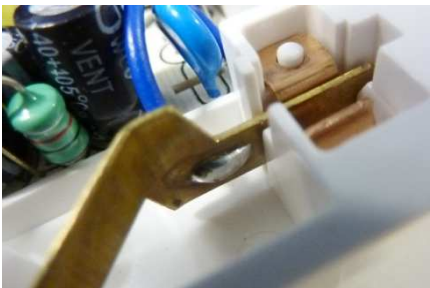
| Terminals & Terminations<br>(BS 1363, Clause 11) | |
|---|---|
| Comments | <p>The connections to the PCB were found to be mechanically secured and soldered. The input and output conductors were adequately secured within the mouldings. The connections from the PCB were secured to the output conductors by crimping / soldering or mechanically securing / soldering.</p> |

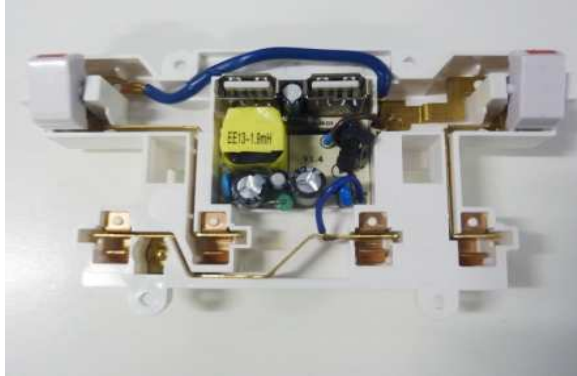
**Internal Overview**

| Terminals & Terminations<br>(BS 1363, Clause 11) | |
|---|---|
| Comments | <p>The output (SELV) circuit was found to be adequately separated from the input circuit and the protective earth. The PCB was fully encased between the socket face and back mouldings. The internal wiring did not carry any markings to enable verification of 3<sup>rd</sup> party approvals.</p> |

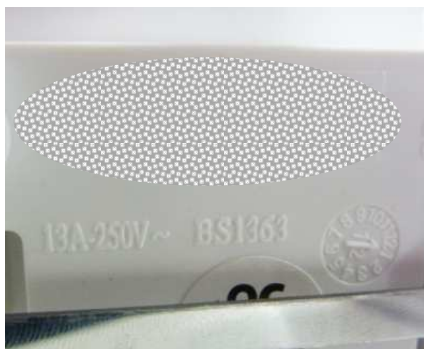
**Markings**

| Findings | | | |
|---|---|---|---|
| Comments | <p>The product was marked with model reference, distributor name, BS 1363 and the sockets electrical ratings. The USB's electrical ratings were printed on the front face; however this could be removed by just rubbing by hand. No regulated rub test was carried out as it was deemed un-necessary. The WEEE logo and CE marking were also missing from the product and packaging.</p> <p>An instruction leaflet was provided which included an adequate amount of information regarding the products technical specification and installation. Both the packaging and instructions stated that the product was suitable for mobile phones, Blackberry, iPods, iPhones, PDA's and MP3's. A statement advising the user that the product will trip should the current exceed 1.2A was also noted.</p> | | |
