# Safety Screening Report

**Report:** 071-75924520-302 **Date:** 09/01/2014

**Product:** Electrical Socket **ESC Sample Number:** 1

**Summary:** TÜV SÜD Product Service was commissioned by The Electrical Safety Council to evaluate an Electrical Socket (see figure 1). The aim of the assessment is to assess the product against the clients Safety Screening Test Plan.

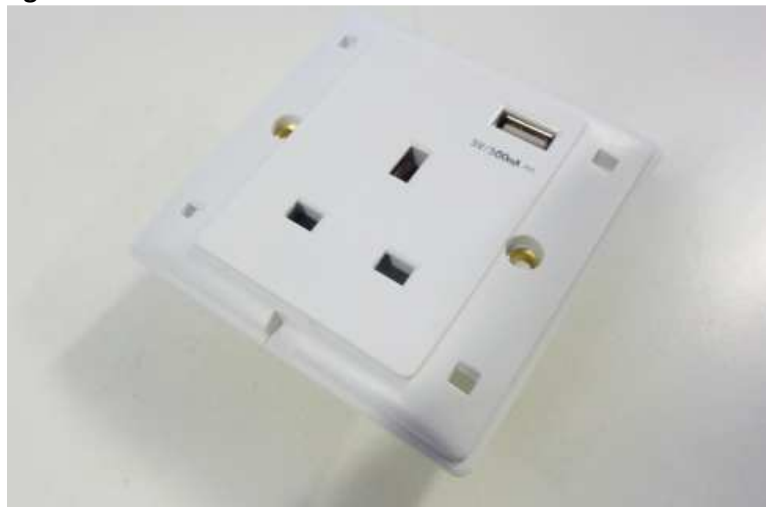
**Figure 1**

The product was of adequate external construction but it failed to accept several BS1363 plugs. Internal construction was poor and the product had several markings were also missing from the product.

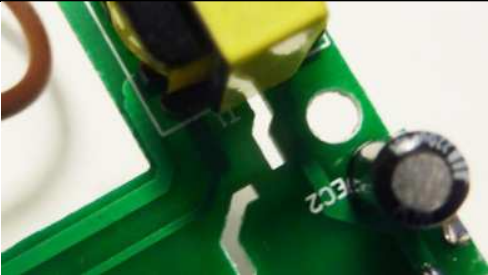
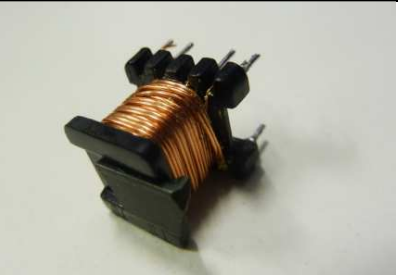
| Terminals & Terminations<br>(BS 1363, Clause 11) | |
|---|---|
| Comments | The minimum creepage distance measured between the primary and secondary side of the circuit board was found to be within the limit; however a clearance distance of 2.25mm was measured. Although there was the addition of a 1mm slot, it did still did not meet the minimum requirement of the standard. There was no measurable distance between the primary and secondary transformer windings (touching). The standard requires a minimum of 5mm in both instances. |

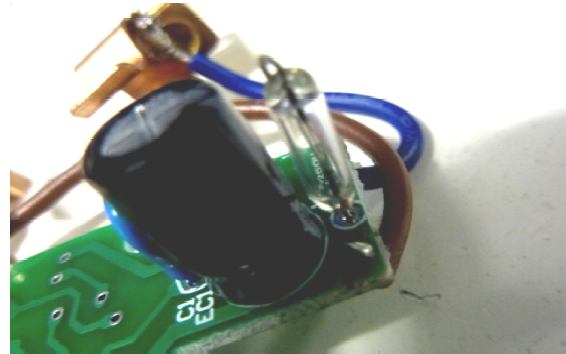
**Fuse**

| <b>Comments</b> | A 1A, glass fuse was suitably fitted to the primary side of the circuit. There was no thermal protection present. Although not a requirement it is recommended that a thermal link is incorporated into the circuit. |
